# VALLEY FALLS DAM

VERNON, CONNECTICUT

## INSPECTION REPORT

Re: Engineering Inspection  
Valley Falls Pond Dam / DEP #14612  
Vernon

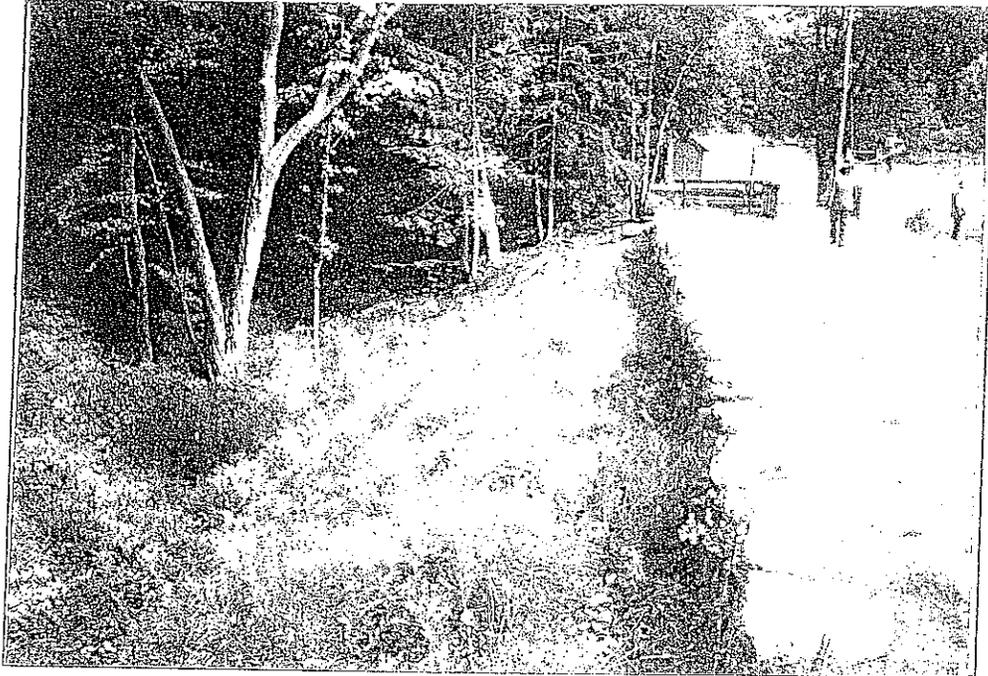
1097B-4

- [1097B-4] Overview of the downstream embankment taken from the left side of the dam. Note the stone wall on the downstream crest and brush growing on the embankment and at the toe areas.

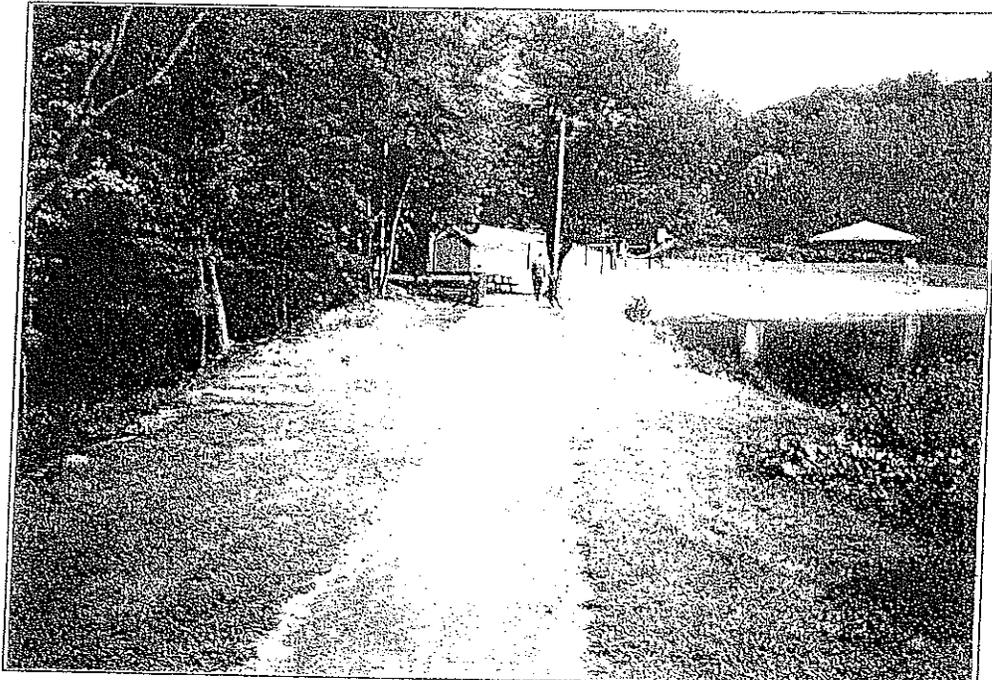
1097B-5

- [1097B-5] The crest of the dam looking toward the right abutment area, taken from the left side adjacent to the secondary spillway. The bridge in the background crosses the primary spillway.

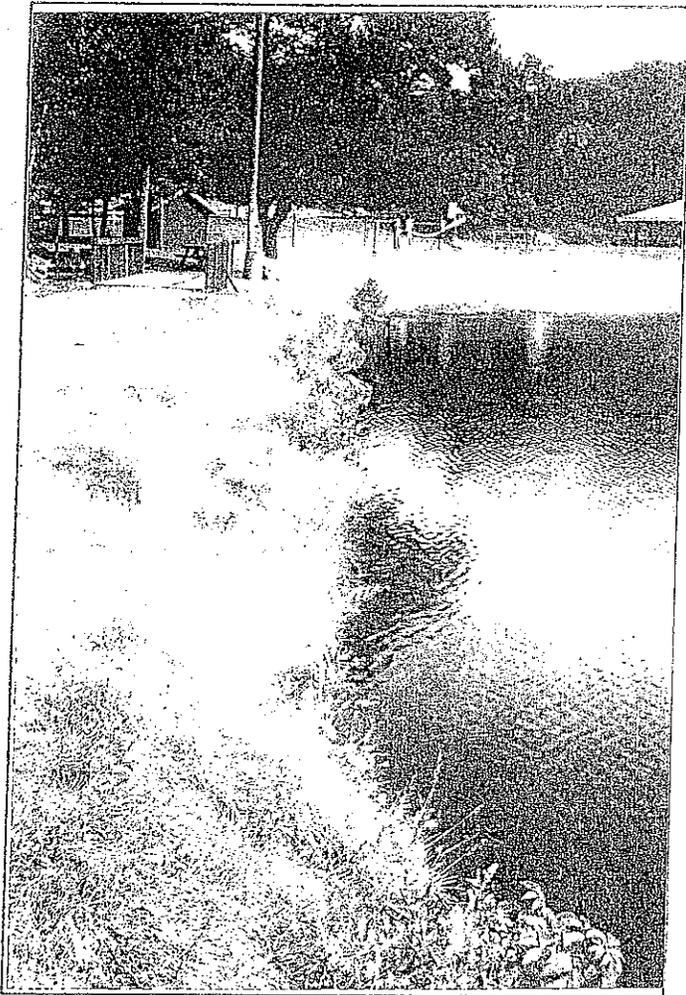
1097B-6

- [1097B-6] The upstream side of the embankment. This view was taken from the center left side looking toward the beach area. Note the drop-off at the water line and tree stumps in various locations.

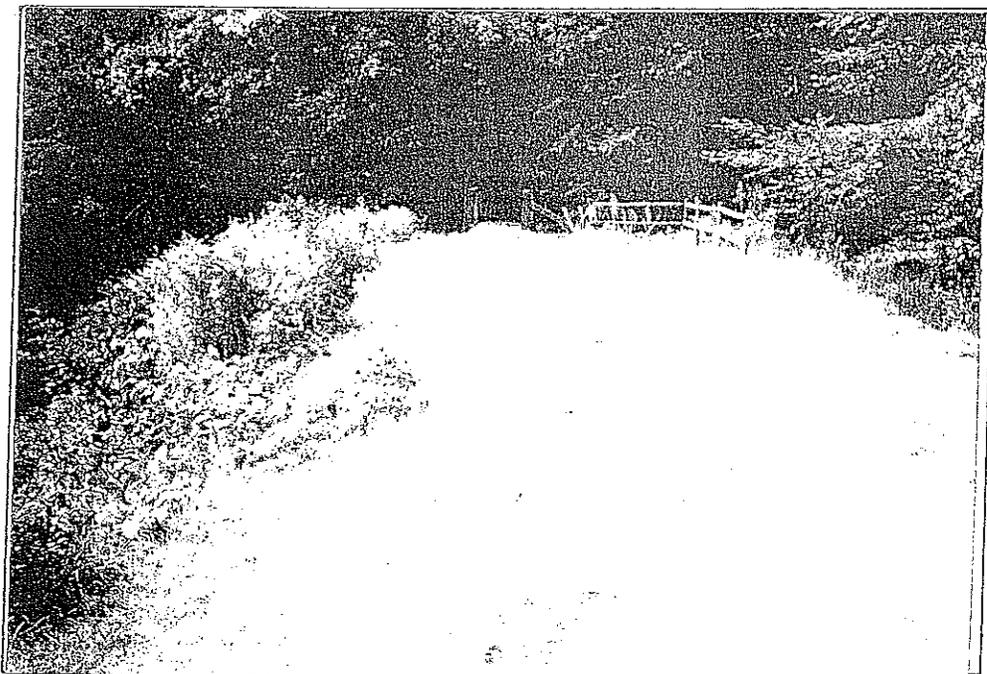
1097B-7

- [1097B-7] Another view of the upstream side looking toward the left end of the dam. Note the vegetative and small brush growth along the water line.
- [1097B-8] The left downstream embankment seen from the approximate center of the dam. Once again, note the small brush growth and the presence of a large stump in the right foreground.

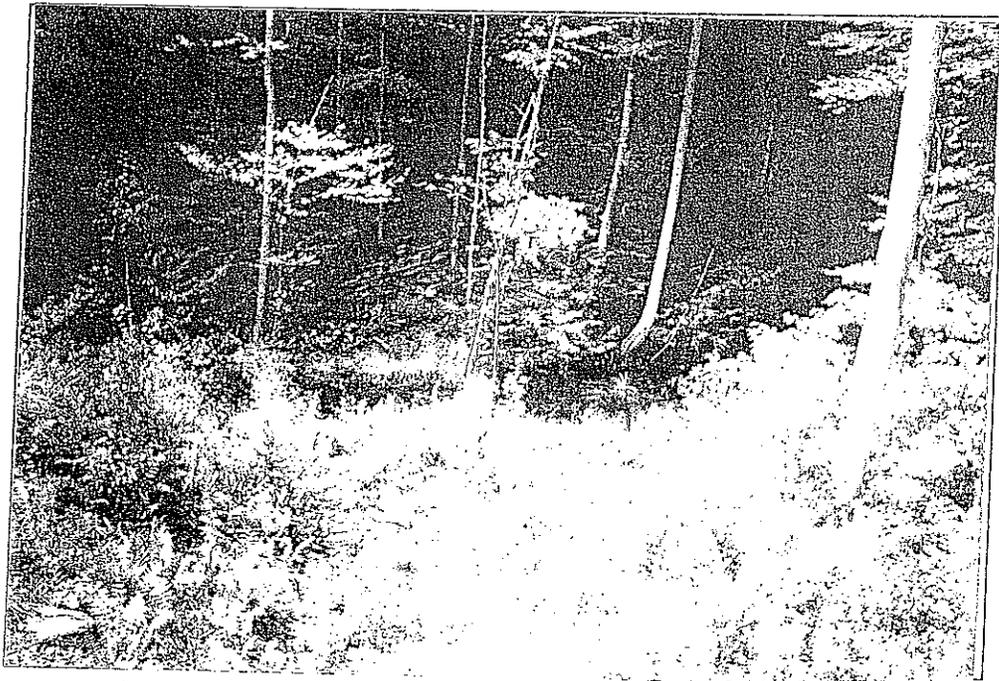
1097B-9

- [1097B-9] A view of the toe area in the same vicinity as the prior photo, the left downstream embankment. The secondary spillway discharge channel is in the background. The tree to the right is closer than the recommended distance to the toe of the dam.

- (1) **Remove Additional Trees** - At the left and right abutment areas, there are some trees close to the walls and embankments. The recommended separating distance from tree growth to any portion of the dam, toe or other embankment areas ranges from 20 to 30 feet. Because of extensive root growth of the trees in this area, I would recommend at least 25 feet.

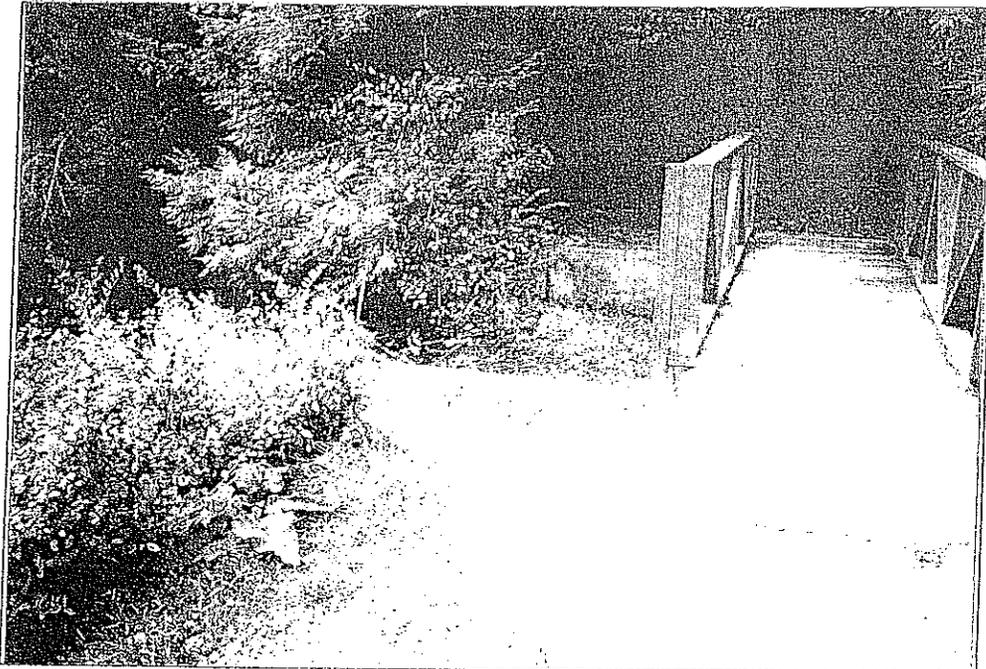
1097B-11

- [1097B-11] A view of the upstream end of the secondary spillway. Note the vegetative growth on the embankments, along walls and in the spillway channel. In addition, tree growth on the left side of the spillway is too close. The bridge and hiking path are seen on the right side of the photo.

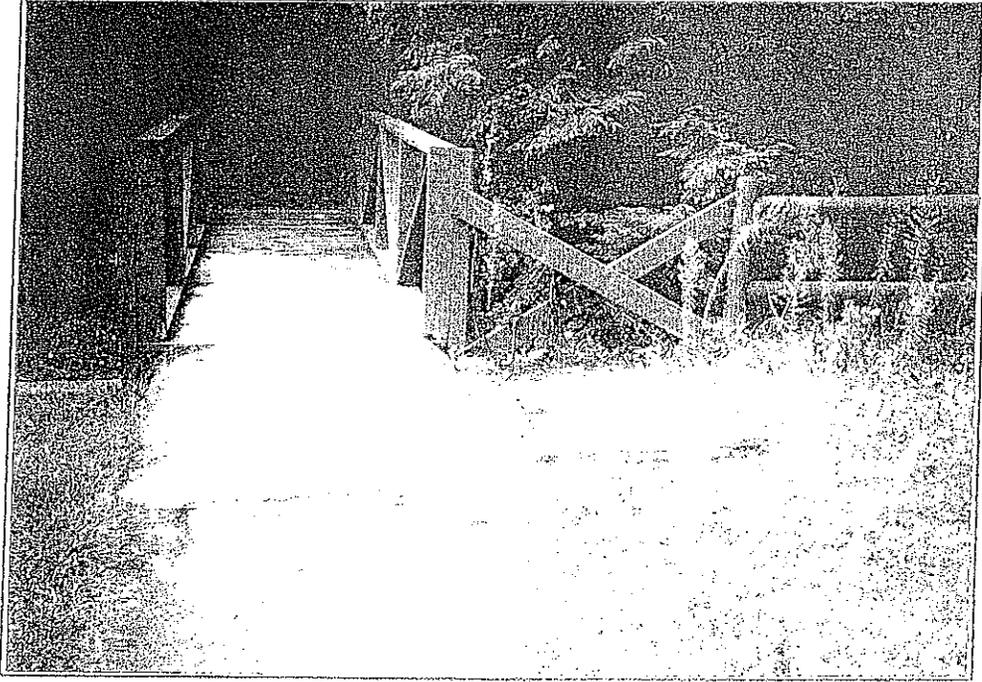
1097B-12

Existing fencing located at the secondary spillway is in poor condition, with missing rail and deteriorating wood. In addition, there are additional areas that should have safety fencing along the spillway and downstream stone wall.

- [1097B-12] A view of the bridge crossing the secondary spillway. In the right center of the photo is the wooden manhole cover for the outlet structure. Fencing is located along the edge of the spillway. Once again note the proximity of trees on the left abutment.

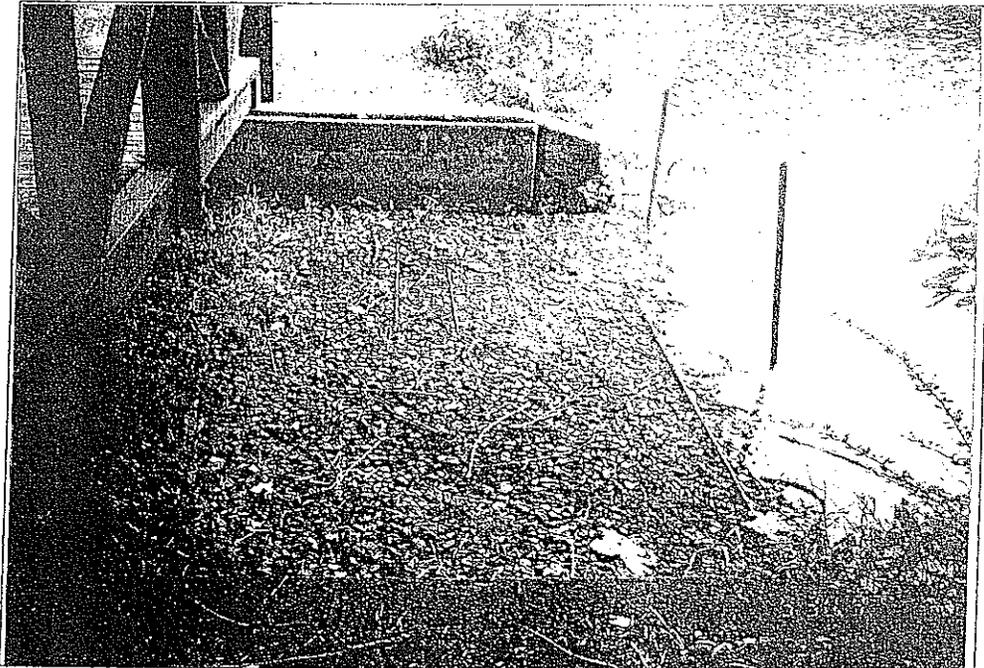
1097B-13

Secondary - The concrete is in poor condition. There are spalled areas along the training walls, and the top of the base slab has completely deteriorated. The top of the slab is gone, probably eroded by flow; aggregate has unraveled and rebar is showing in many locations. Grass is also growing in the top surface of the former slab.

- [1097B-13] The upstream end of the spillway channel looking toward the right side of the dam. The top surface of the slab has deteriorated completely and rebar is clearly visible. Note also the poor condition of the training wall on the right side of the slab.

(5) **Remove and Reconstruct the Existing Primary Spillway** - Because of poor flow conditions, unknown foundation conditions, open masonry construction and possible voids behind the walls, I would recommend removing and then reconstructing this spillway section. It could be incorporated into the newer spillway construction, but may be historically significant in its present location. Facing, as previously mentioned, could be actual stone or form liners to give a stone appearance. Because the existing slope drain from the beach area now discharges below water level at the upstream end of this spillway, I would recommend relocating it as shown on the sketch in order to more easily monitor and maintain it.

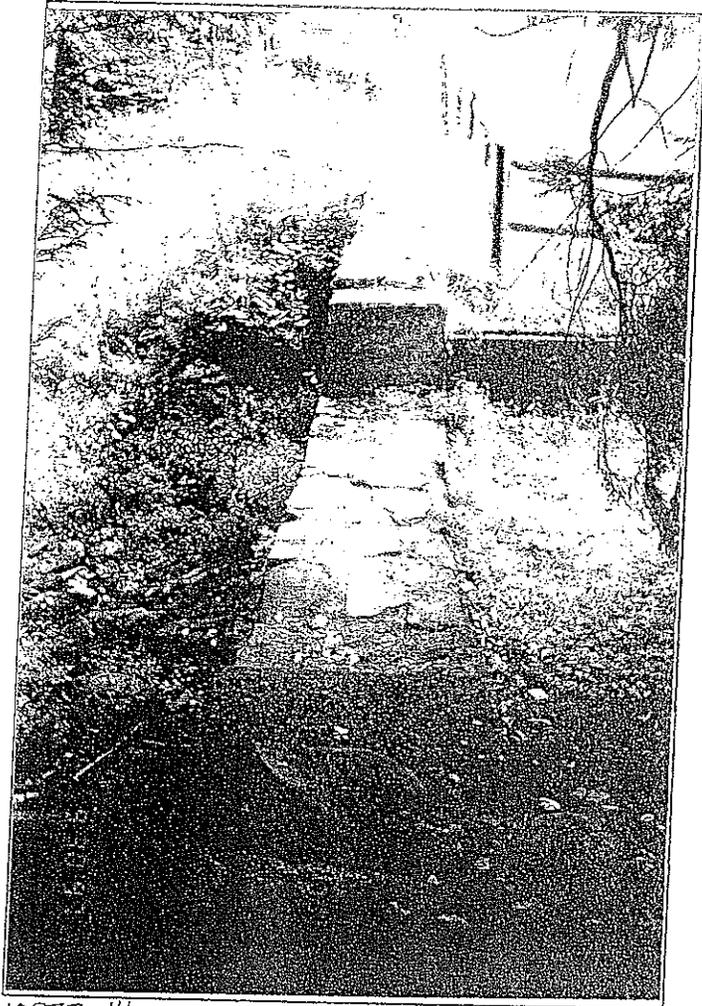
1097B-14

- [1097B-14] The downstream spillway crest consists of stone masonry. Note the concrete training walls on both sides and the vegetation growing in the channel.

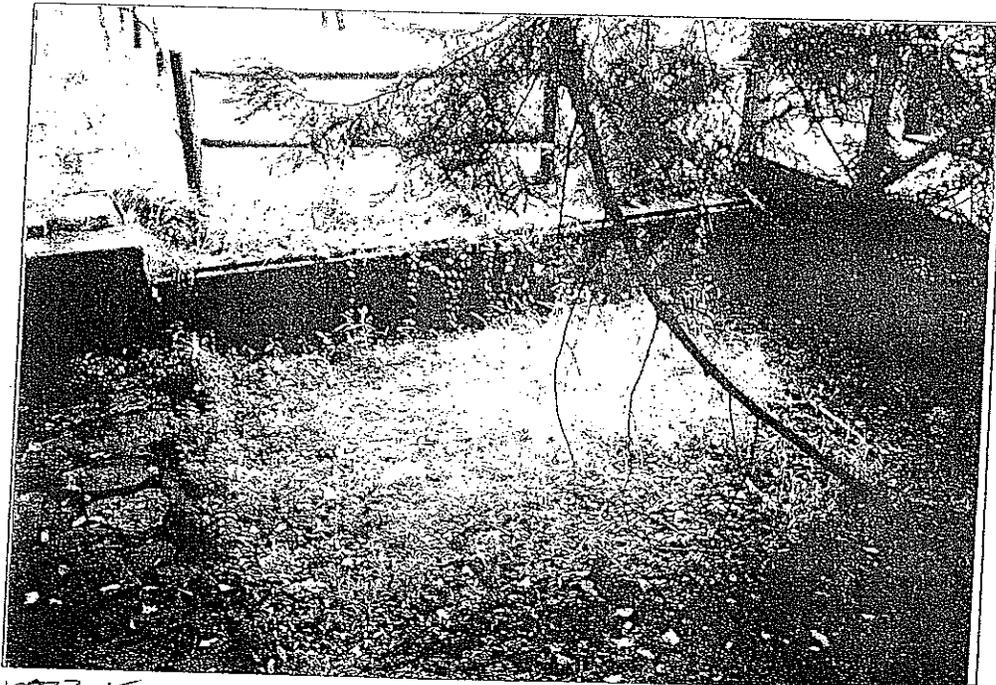
1097B-15

- [1097B-15] Another view of the spillway channel showing vegetation growing in the deteriorated concrete slab.
- [1097B-16] The downstream stone masonry wall of the secondary spillway; view taken from the left side.

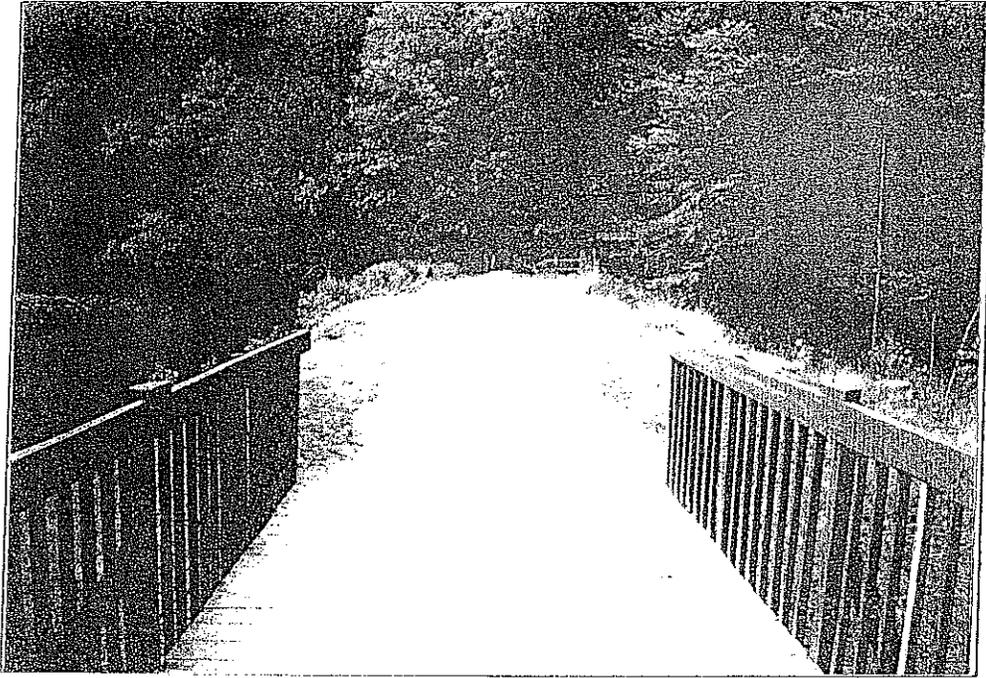
1097C-1

- [1097C-1] Looking across the primary spillway bridge toward the left end of the dam. The access path for maintenance and hiking runs along the center line of the dam's crest.

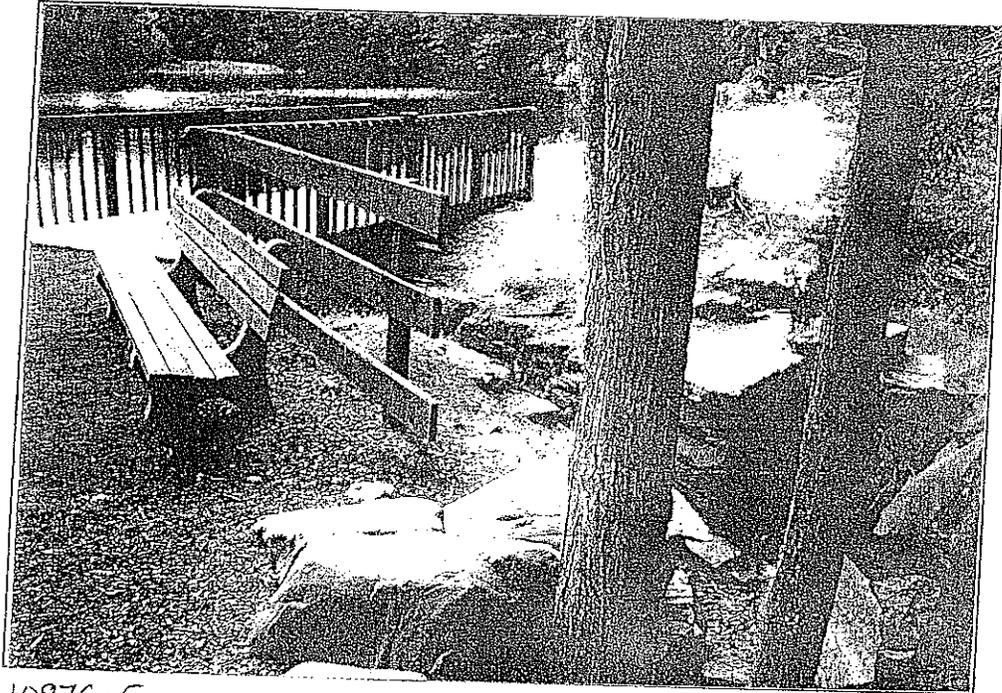
1097C-5

- [1097C-5] Another view of the downstream end of the primary spillway discharge channel as seen from the right abutment area. The trees in the foreground are too close to the downstream embankment wall.
