SILVA ENGINEERING, LLC

June 19, 2014
Project No. 14140

Ref: Lucina Memorial Chapel
Grove Hill Cemetery
Evaluation of Stone Masonry Walls

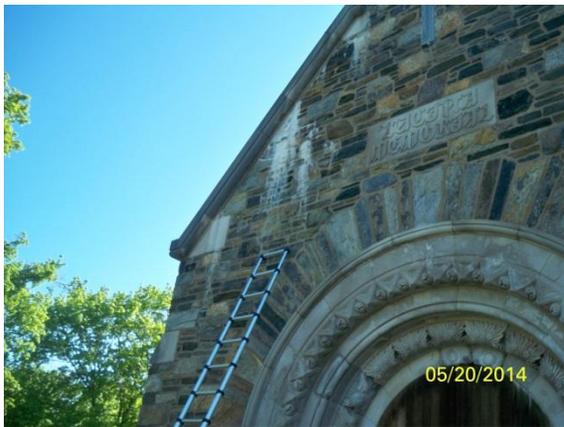
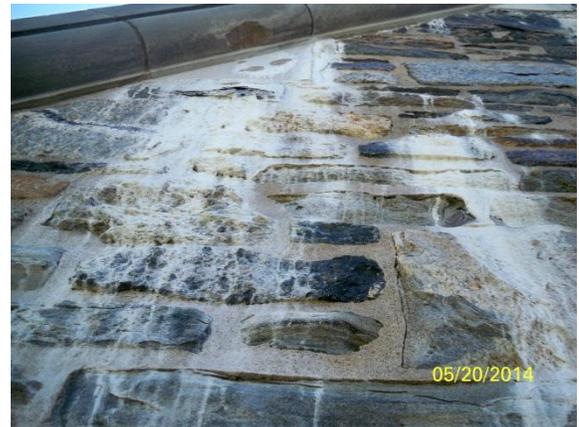
Efflorescence, a "whitish haze of soluble salts into the masonry caused by excessive pulling of the soluble salts into the masonry and out through the surface"³, was visible on both the interior and exterior surfaces of the gable end wall rubble stones. On the exterior face, efflorescence originated just below the gable coping limestone units and extends to the level of the door archway stones. Efflorescence is more pronounced to the left of the entrance, but also extends up to the bell tower coping limestone units.

Exterior Efflorescence

- Utilize high permeable mortar similar to that used for repairs to Fox Hill Monument i.e. high lime mortar.
- Repoint rubble stone joints at front (entrance) gable end wall.
- Repoint bell tower and chimney above roof line.
- Repoint all joints between gable end coping limestones.

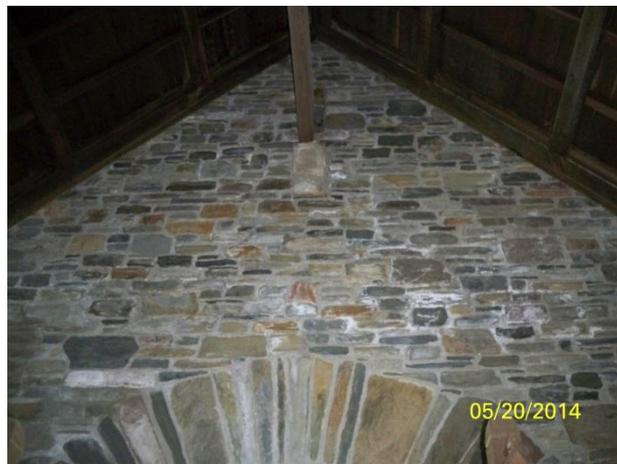
Interior Efflorescence

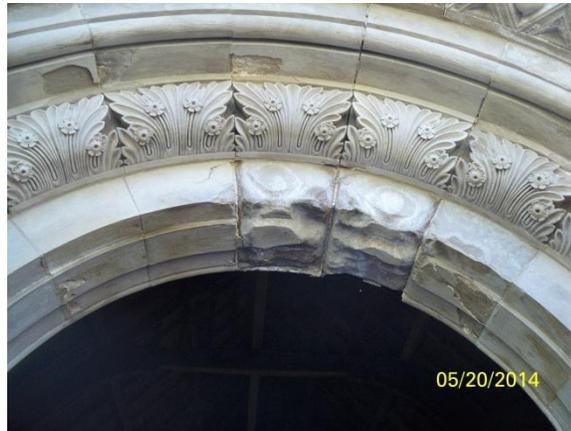
The dressed cut limestone around the front entrance door is also showing signs of distress, including delamination, exfoliation, weathering, and spalling.

Damaged Limestones at Doorway Arch

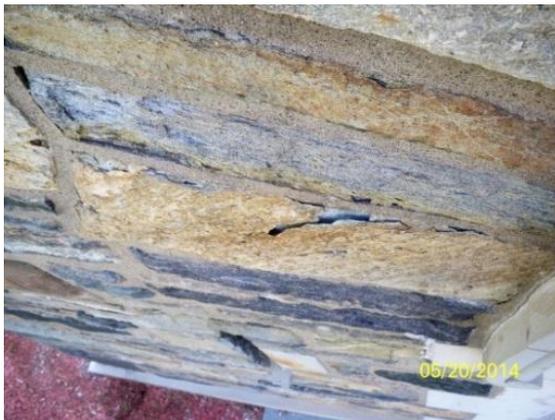
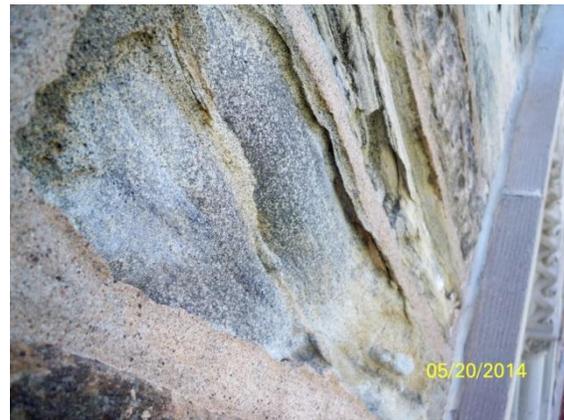
The exterior faces of the rubble stones also exhibit both delamination and exfoliation of the stone masonry, however the adjoining mortar joints were observed to be intact. No records of repointing the exterior stone masonry of the building have been discovered but the observed conditions indicate that repointing likely was completed at one time. Our observation of the damage to the masonry stones also indicate that it is likely that an improper mortar was used during repointing.

**View of Delaminated Rubble Stone – Note that mortar joints are intact
Looking down from top of wall towards grade (left) and entrance arch (right)**

Based on the observed conditions and damage, it appears the building was repointed at one time with a hard, dense mortar that is less permeable than the masonry rubble stones. As described above, the rubble stone could not "give" due to the hard mortar repair, which resulted in hairline cracks of the rubble stone face. Additionally, the hard mortar prevented moisture from wicking to the exterior through the mortar joints.

1. Minimum Recommendations
 - Repoint exterior joints for remainder of building.
 - Remove and reset gable end coping limestone, and repair of damaged areas exposed subsequent to removal of stone. Also determine need for installation of flashing below coping stones.
2. Additional Repairs for Consideration
 - Repair or replace damaged limestone at entrance doorway.
 - Replace damaged rubble stones, if needed.
 - Clean stone masonry surfaces to remove efflorescence stains using proper water washing techniques.
3. Determine work forces, i.e. Town Staff or independent contractor.
4. Develop documents/drawings as per extent of repairs and type of workforce to be utilized.
