Town of Vernon Connecticut

Stormwater Management Plan

2011 Annual Report

March 26, 2012

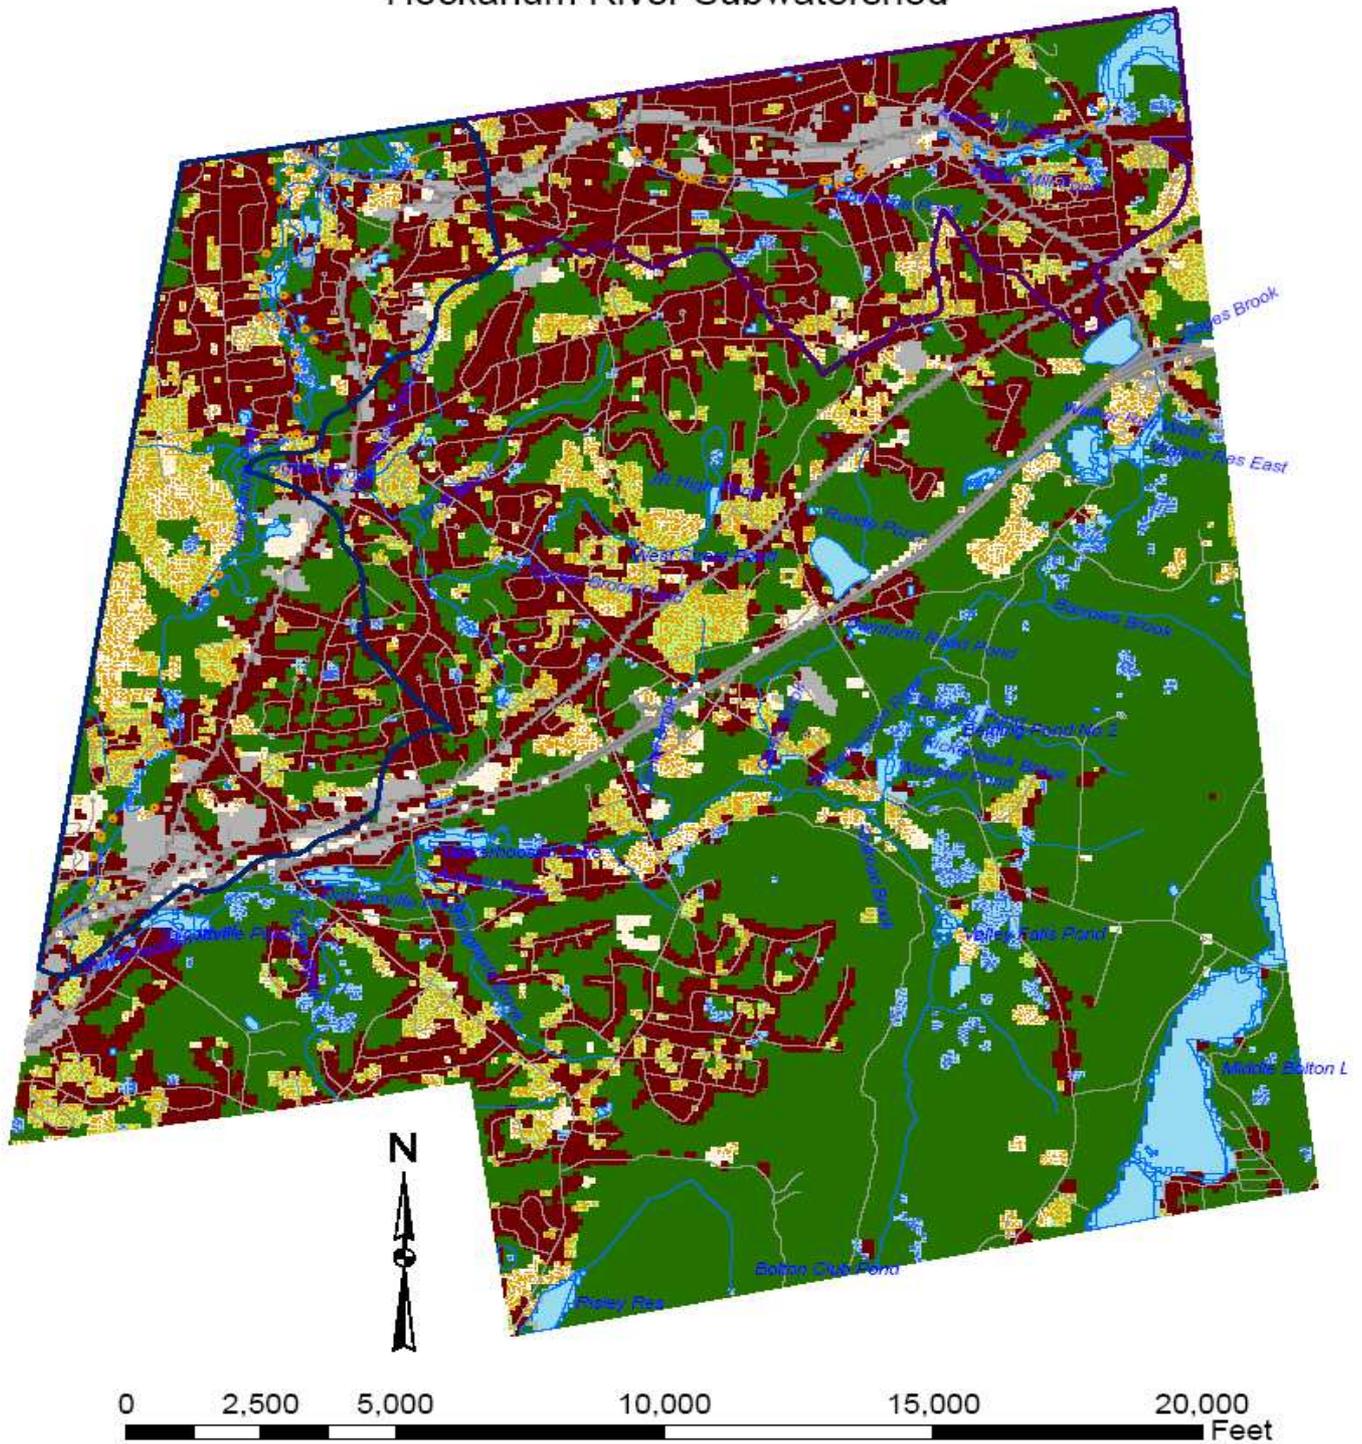
1990 Land Use / Land Cover in Vernon, Connecticut Hockanum River Subwatershed

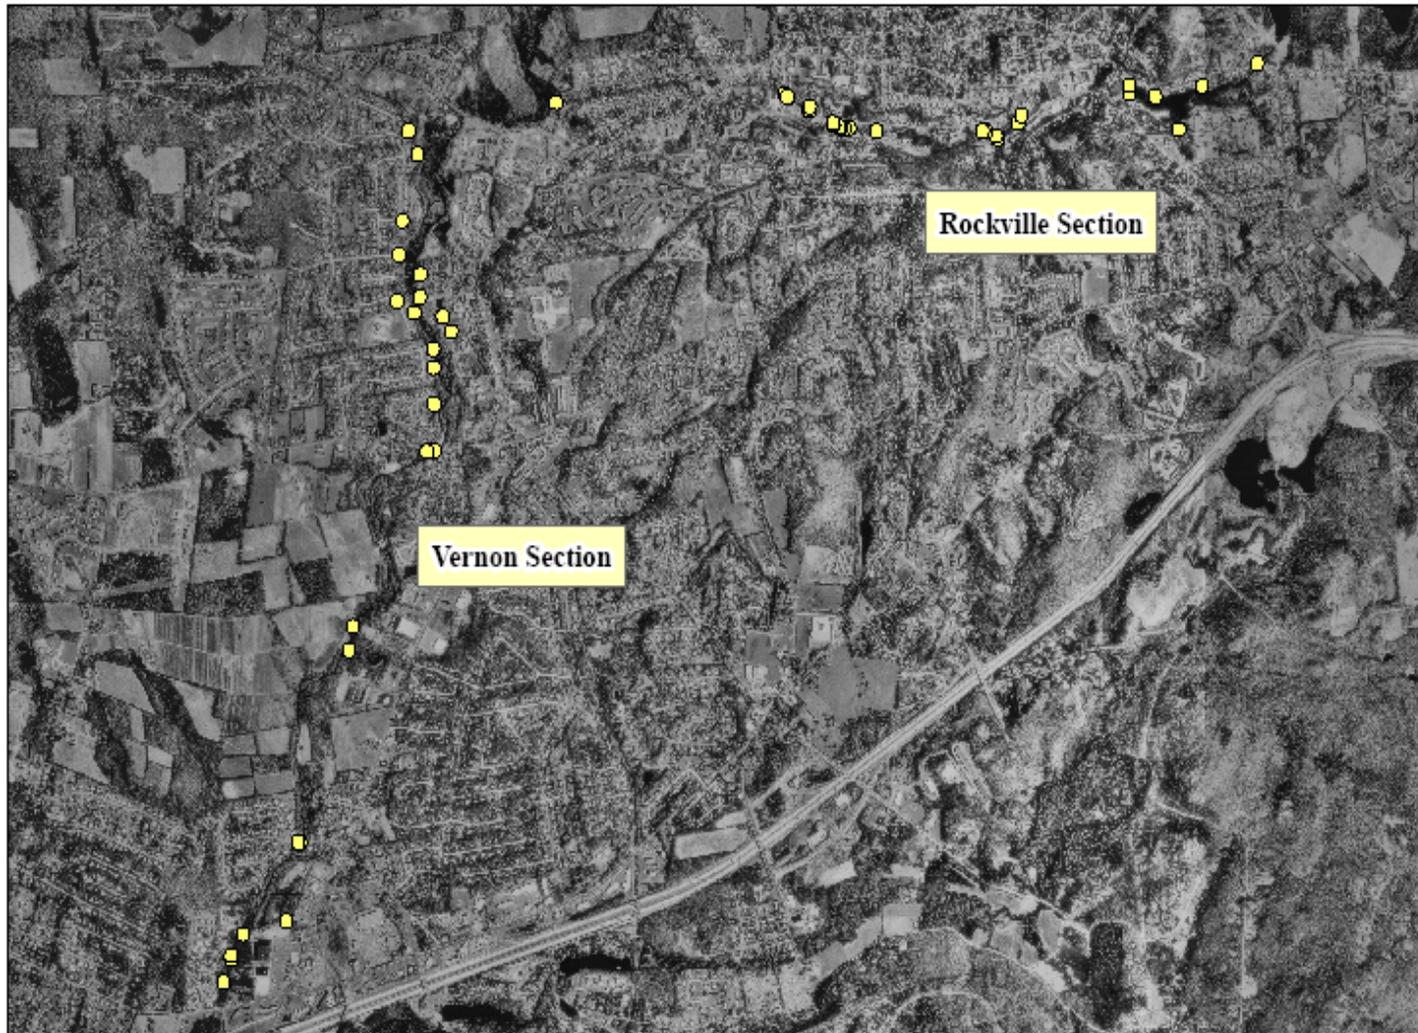
Vernon Hockanum River Stormwater Outfall Locations

As outlined in the Scope of Work in the North Central Conservation District NPS Management contract 08-04b, outfalls in the town of Vernon were evaluated and prioritized for repair, retrofit or upgrade in accordance with the MS4 General Permit's Minimum Control Measure Item 6, which requires development and implementation of a program to evaluate conveyances, structures, and outfalls for repair and retrofit. Discharges were categorized into low, moderate, and high priority based on several factors including: the expected pollutant load, the condition of the infrastructure, sedimentation and/or erosion, fish passage, the relative value of the receiving wetland or waterbody as a resource, and the extent of its degradation. In total, district staff identified six moderate priority discharges and five high priority discharges.
