APPENDIX C
TV Inspection Logs

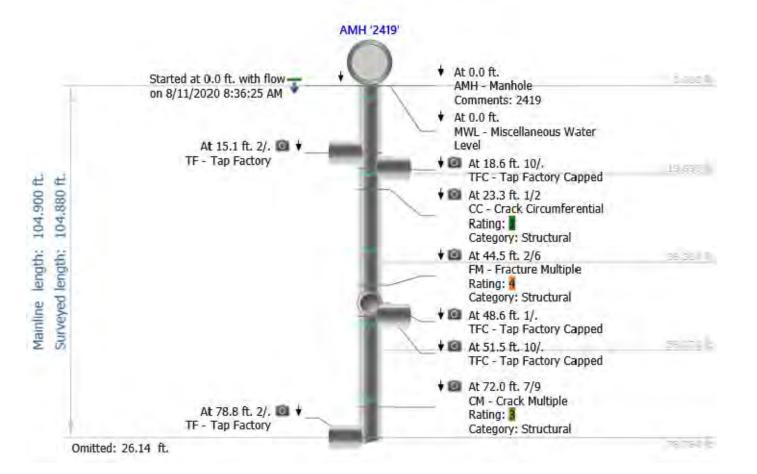
Start date/time:	Weather:		Surveyed by:	Certificate number:	Pipe segment ref.:	
20200811 08:36	Dry - No precipitation	durina	J.HASHEM	000-0000-0000	2419-367	
	survey					
Owner:	Customer:		Pre-cleaning:	Date cleaned:	Project name:	
			Light Cleaning		TIG001-23	
City:	Street:		Location code:	Pipe use:	Drainage area:	Flow control:
VERNON CT	CHESTNUT S	ST		Sanitary Sewage Pipe		
Upstream MH No:	Do	ownstream	MH No:	Direction:	Total length:	Length surveyed:
2419	30	67		D	104.900 ft.	104.880 ft.
Purpose: Pipe joi	int length: He	eight:	Material:	LateralsCounter:	Additional info:	
Maintenan ce Related	8	in.	Vitrified Clay Pipe

Structura	ıl:				O&M:				Over	all:	
Grade	Defects	Segment Grade	Pipe Rating	Quick Rating	Pipe Rating Index	Defects	Segment Grade	Pipe Rating	Quick Rating	Pipe Rating Index	Pipe Rating	Pipe Rating Index	LoF	Risk
1	0	1				0	0							
2	0	0				0	0							
3	0	3	16	4331	3.2	0	0	0	0000	0.0	16	3.2	4.3	
4	0	12				0	0							
5	0	0				0	0

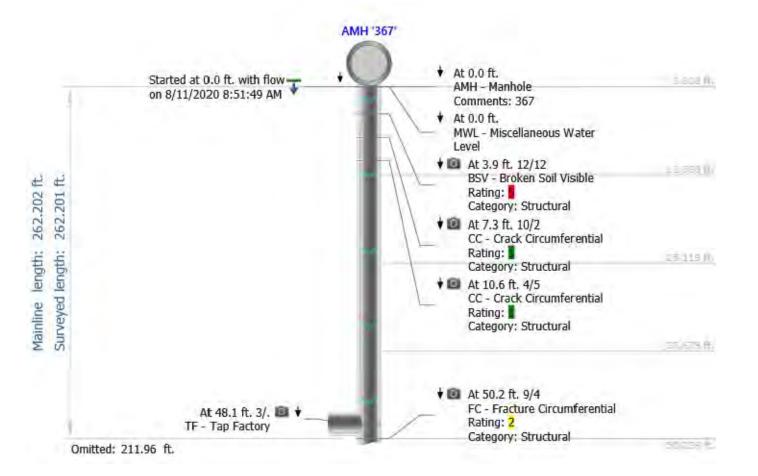
Start date/time:	Weather:		Surveyed by:	Certificate number:	Pipe segment ref.:	
20200811 08:51	Dry - No precipitation	on during	J.HASHEM	000-0000-0000	367-366	
	survey					
Owner:	Customer:		Pre-cleaning:	Date cleaned:	Project name:	
			Light Cleaning		TIG001-23	
City:	Street:		Location code:	Pipe use:	Drainage area:	Flow control:
VERNON CT	CHESTNU	T ST		Sanitary Sewage Pipe		
Upstream MH No:		Downstrea	m MH No:	Direction:	· Total length:	Length surveyed:
367		366		D	262.202 ft.	262.201 ft.
Purpose: Pipe jo	int length:	Height:	Material:	LateralsCounter:	Additional info:	
Maintenan ce Related ———		8 in.	Vitrified Clay Pipe

Structura	ıl:				O&M:				Over	rall:	
Grade	Defects	Segment Grade	Pipe Rating	Quick Rating	Pipe Rating Index	Defects	Segment Grade	Pipe Rating	Quick Rating	Pipe Rating Index	Pipe Rating	Pipe Rating Index	LoF	Risk
1	0	4				0	0							
2	0	4				0	0							
3	0	15	28	5135	2.3	0	0	0	0000	0.0	28	2.3	5.1	
4	0	0				0	0							
5	0	5				0	0

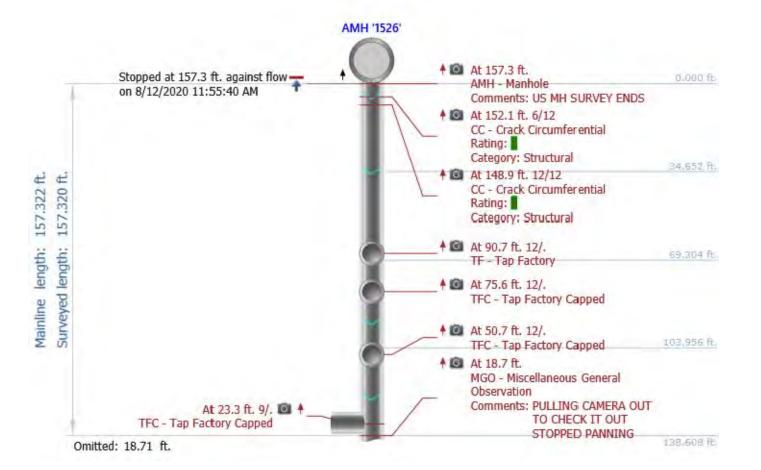
Start date/time:	Weather:		Surveyed by:	Certificate number:	Pipe segment ref.:	
20200812 11:33	Dry - No	ion during	alberto	u-0220-70308624	1526-1958	
	survey	ion during				
Owner:	Customer:		Pre-cleaning:	Date cleaned:	Project name:	
			Light Cleaning		TIG001-23	
City:	Street:		Location code:	Pipe use:	Drainage area:	Flow control:
VERNON CT	COTTAGE	ST		Sanitary Sewage Pipe		<b>」</b>
Upstream MH No:		Downstrea	am MH No:	Direction:	• Total length:	Length surveyed:
1526		1958		U	157.322 ft.	157.320 ft.
Purpose: Pipe j	oint length:	Height:	Material:	LateralsCounter:	Additional info:	
Maintenan ce Related ———		8 in.	Vitrified Clay Pipe		ACCIDENTALY TY	PED IN WRONG MH #

Structura	ıl:				O&M:				Over	rall:	
Grade	Defects	Segment Grade	Pipe Rating	Quick Rating	Pipe Rating Index	Defects	Segment Grade	Pipe Rating	Quick Rating	Pipe Rating Index	Pipe Rating	Pipe Rating Index	LoF	Risk
1	0	2				0	0							
2	0	0				0	0							
3	0	0	6	4112	2.0	0	0	0	0000	0.0	6	2.0	4.1	
4	0	4				0	0							
5	0	0				0	0

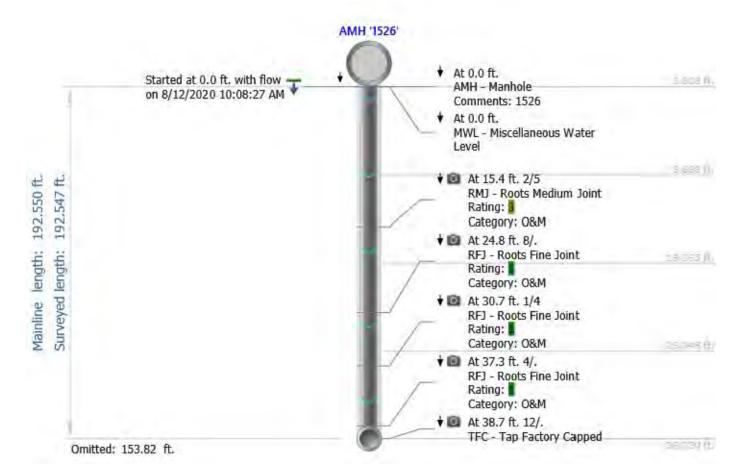
Start date/time:	Weather:		Surveyed by:	Certificate number:	Pipe segment ref.:	
20200812 10:08	Dry - No	ion during	alberto	u-0220-70308624	1526-1527	
	survey	ion during				
Owner:	Customer:		Pre-cleaning:	Date cleaned:	Project name:	
			Light Cleaning		TIG001-23	
City:	Street:		Location code:	Pipe use:	Drainage area:	Flow control:
VERNON CT	COTTAGE	ST		Sanitary Sewage Pipe		
Upstream MH No:		Downstrea	nm MH No:	Direction:	Total length:	Length surveyed:
1526		1527		D	192.550 ft.	192.547 ft.
Purpose: Pipe	joint length:	Height:	Material:	LateralsCounter:	Additional info:	
Maintenan ce Related —		8 in.	Vitrified Clay Pipe

Structura	al:				O&M:				Overall:		
Grade	Defects	Segment Grade	Pipe Rating	Quick Rating	Pipe Rating Index	Defects	Segment Grade	Pipe Rating	Quick Rating	Pipe Rating Index	Pipe Rating	Pipe Rating Index	LoF	Risk
1	0	0				0	4							
2	0	0				0	0							
3	0	9	13	4133	3.2	0	3	7	3114	1.4	20	2.2	4.1	
4	0	4				0	0							
5	0	0				0	0

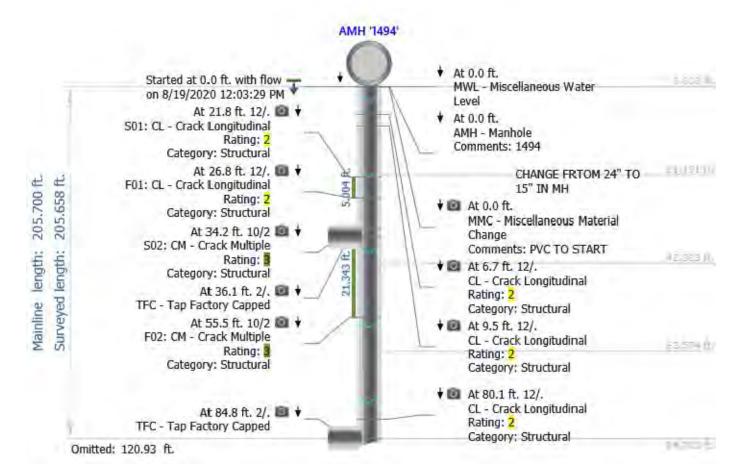
Start date/time:	Weather:	Surveyed by:	Certificate number:	Pipe segment ref.:	
20200819 12:03	Dry - No precipitation du	J.HASHEM	000-0000-0000	1494/151	
	survey				
Owner:	Customer:	Pre-cleaning:	Date cleaned:	Project name:	
		Light Cleaning		TIG001-23	
City:	Street:	Location code:	Pipe use:	Drainage area:	Flow control:
VERNON CT	EAST MAIN ST		Sanitary Sewage Pipe		
Upstream MH No:	Dow	nstream MH No:	Direction:	Total length:	Length surveyed:
1494	151		D	205.700 ft.	205.658 ft.
Purpose: Pipe jo	int length: Heig	ht: Material:	LateralsCounter:	Additional info:	
Maintenan ce Related	15 ir	n. Vitrified Clay

Structura	ıl:				O&M:				Overall:			
Grade	Defects	Segment Grade	Pipe Rating	Quick Rating	Pipe Rating Index	Defects	Segment Grade	Pipe Rating	Quick Rating	Pipe Rating Index	Pipe Rating	Pipe Rating Index	LoF	Risk	
1	0	0				0	0								
2	0	24				0	0								
3	0	18	42	362A	2.3	0	0	0	0000	0.0	42	2.3	3.6		
4	0	0				0	0								
5	0	0				0	0

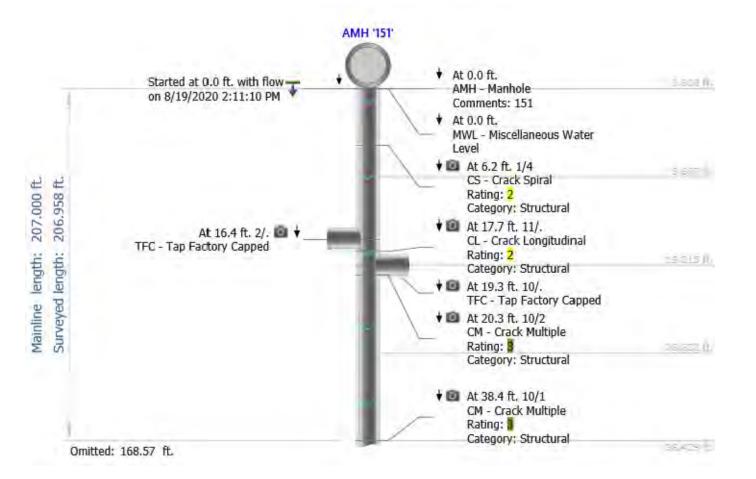
Start date/time:	Weather:		Surveyed by:	Certificate number:	Pipe segment ref.:	
20200819 14:11	Dry - No precipitation	n during	J.HASHEM	000-0000-0000	151/887	
	survey	on during				
Owner:	Customer:		Pre-cleaning:	Date cleaned:	Project name:	
			Light Cleaning		TIG001-23	
City:	Street:		Location code:	Pipe use:	Drainage area:	Flow control:
VERNON CT	EAST MAIN	I ST		Sanitary Sewage Pipe		
Upstream MH No:		Downstrea	m MH No:	Direction:	Total length:	Length surveyed:
151		887		D	207.000 ft.	206.958 ft.
Purpose: Pipe jo	oint length:	Height:	Material:	LateralsCounter:	Additional info:	
Maintenan ce Related		15 in.	Vitrified Clay Pipe

Structura	al:				O&M:				Over	rall:	
Grade	Defects	Segment Grade	Pipe Rating	Quick Rating	Pipe Rating Index	Defects	Segment Grade	Pipe Rating	Quick Rating	Pipe Rating Index	Pipe Rating	Pipe Rating Index	LoF	Risk
1	0	1				0	0							
2	0	30				0	0							
3	0	69	100	3C2B	2.6	0	0	0	0000	0.0	100	2.6	4.0	
4	0	0				0	0							
5	0	0				0	0

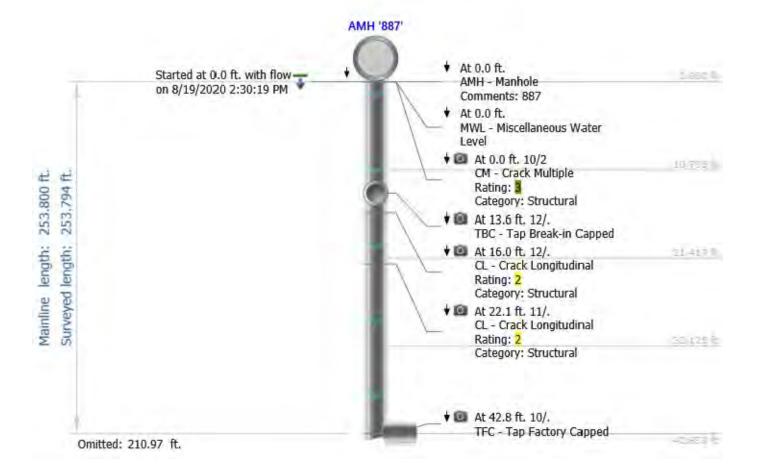
Start date/time:	Weather:		Surveyed by:	Certificate number:	Pipe segment ref.:	
20200819 14:30	Dry - No precipitation	n during	J.HASHEM	000-0000-0000	887/1750	
	survey	on during				
Owner:	Customer:		Pre-cleaning:	Date cleaned:	Project name:	
			Light Cleaning		TIG001-23	
City:	Street:		Location code:	Pipe use:	Drainage area:	Flow control:
VERNON CT	EAST MAIN	I ST		Sanitary Sewage Pipe		
Upstream MH No:		Downstrea	ım MH No:	Direction:	· Total length:	Length surveyed:
887		1750		D	253.800 ft.	253.794 ft.
Purpose: Pipe j	oint length:	Height:	Material:	LateralsCounter:	Additional info:	
Maintenan ce Related		15 in.	Vitrified Clay Pipe

Structura	ıl:		O&M:					Overall:			
Grade	Defects	Segment Grade	Pipe Rating	Quick Rating	Pipe Rating Index	Defects	Segment Grade	Pipe Rating	Quick Rating	Pipe Rating Index	Pipe Rating	Pipe Rating Index	LoF	Risk
1	0	3				0	0							
2	0	10				0	0							
3	0	9	30	4233	2.3	0	0	0	0000	0.0	30	2.3	4.2	
4	0	8				0	0							
5	0	0				0	0

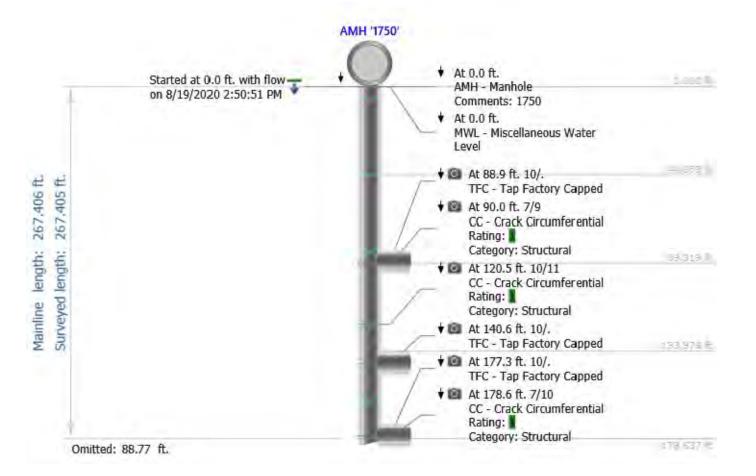
Start date/time:	Weather:	Surveyed by:	Certificate number:	Pipe segment ref.:	
20200819 14:50	Dry - No precipitation du	J.HASHEM	000-0000-0000	1750/1749	
	survey				
Owner:	Customer:	Pre-cleaning:	Date cleaned:	Project name:	
		Light Cleaning		TIG001-23	
City:	Street:	Location code:	Pipe use:	Drainage area:	Flow control:
VERNON CT	EAST MAIN ST		Sanitary Sewage Pipe		
Upstream MH No:	Dowr	nstream MH No:	Direction:	Total length:	Length surveyed:
1750	1749		D	267.406 ft.	267.405 ft.
Purpose: Pipe joi	int length: Heigh	nt: Material:	LateralsCounter:	Additional info:	
Maintenan ce Related	15 in	. Vitrified Clay Pipe

Structura	al:				O&M:				Over	rall:	
Grade	Defects	Segment Grade	Pipe Rating	Quick Rating	Pipe Rating Index	Defects	Segment Grade	Pipe Rating	Quick Rating	Pipe Rating Index	Pipe Rating	Pipe Rating Index	LoF	Risk
1	0	4				0	1							
2	0	10				0	0							
3	0	9	28	5133	2.2	0	0	1	1100	1.0	29	2.1	5.1	
4	0	0				0	0							
5	0	5				0	0

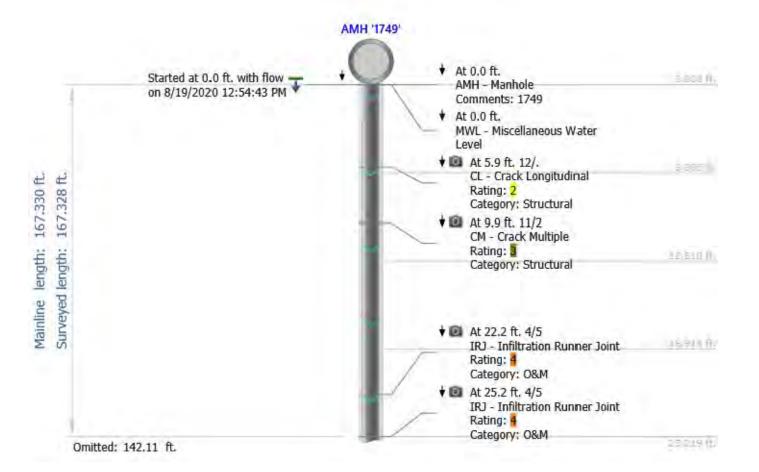
Start date/time:	Weather:	Surveyed by:	Certificate number:	Pipe segment ref.:	
20200819 12:54	Dry - No precipitation during	J.HASHEM	000-0000-0000	1749/894	
	survey				
Owner:	Customer:	Pre-cleaning:	Date cleaned:	Project name:	
		Light Cleaning		TIG001-23	
City:	Street:	Location code:	Pipe use:	Drainage area:	Flow control:
VERNON CT	EAST MAIN ST		Sanitary Sewage Pipe		
Upstream MH No:	Downstre	eam MH No:	Direction:	Total length:	Length surveyed:
1749	894		D	167.330 ft.	167.328 ft.
Purpose: Pipe joi	nt length: Height:	Material:	LateralsCounter:	Additional info:	
Maintenan ce Related	15 in.	Vitrified Clay Pipe

Structura	ıl:				O&M:				Over	rall:	
Grade	Defects	Segment Grade	Pipe Rating	Quick Rating	Pipe Rating Index	Defects	Segment Grade	Pipe Rating	Quick Rating	Pipe Rating Index	Pipe Rating	Pipe Rating Index	LoF	Risk
1	0	0				0	4							
2	0	6				0	0							
3	0	6	12	3223	2.4	0	3	115	4D31	3.6	127	3.4	5.0	
4	0	0				0	108							
5	0	0				0	0

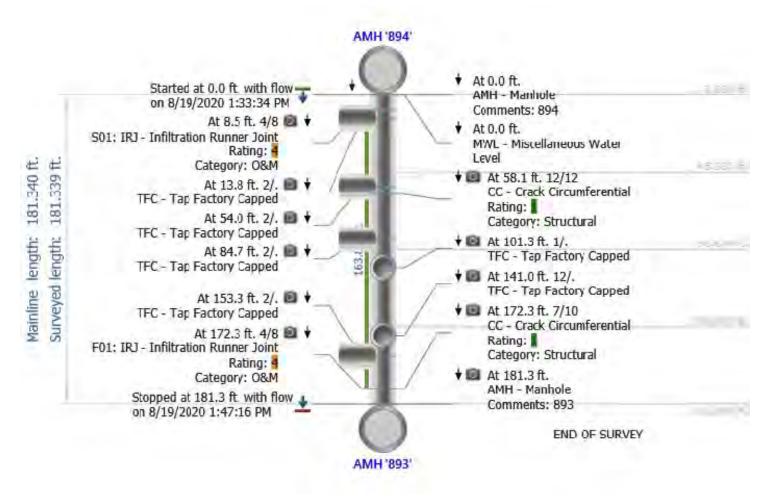
Start date/time:	Weather:		Surveyed by:	Certificate number:	Pipe segment ref.:	
20200819 13:33		tion during	J.HASHEM	000-0000-0000	894/893	
	survey	tion during				
Owner:	Customer	:	Pre-cleaning:	Date cleaned:	Project name:	
			Light Cleaning		TIG001-23	
City:	Street:		Location code:	Pipe use:	Drainage area:	Flow control:
VERNON CT	MAIN ST			Sanitary Sewage Pipe		
Upstream MH No:		Downstrea	am MH No:	Direction:	Total length:	Length surveyed:
894		893		D	181.340 ft.	181.339 ft.
Purpose: Pipe	joint length:	Height:	Material:	LateralsCounter:	Additional info:	
Maintenan ce Related		15 in.	Vitrified Clay Pipe

Structura	nl:				O&M:				Over	all:	
Grade	Defects	Segment Grade	Pipe Rating	Quick Rating	Pipe Rating Index	Defects	Segment Grade	Pipe Rating	Quick Rating	Pipe Rating Index	Pipe Rating	Pipe Rating Index	LoF	Risk
1	0	2				0	0							
2	0	0				0	0							
3	0	0	2	1200	1.0	0	0	132	4E00	4.0	134	3.8	5.0	
4	0	0				0	132							
5	0	0				0	0

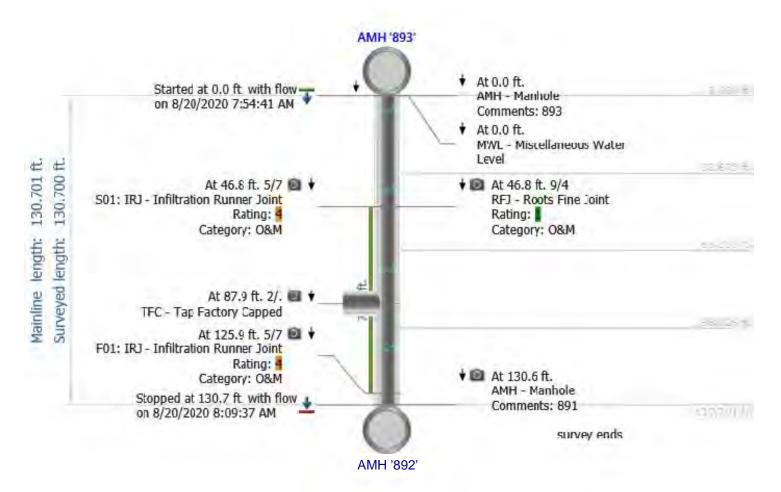
Start date/time:	Weather:	Surveyed by:	Certificate number:	Pipe segment ref.:	
20200820 07:54	Dry - No precipitation during	K.Lang	UO-200-70308438	893-892	
	survey				
Owner:	Customer:	Pre-cleaning:	Date cleaned:	Project name:	
		Light Cleaning		TIG001-23	
City:	Street:	Location code:	Pipe use:	Drainage area:	Flow control:
Vernon	Main ST		Sanitary Sewage Pipe		
Upstream MH No:	Downstr	eam MH No:	Direction:	Total length:	Length surveyed:
893	891		D	130.701 ft.	130.700 ft.
Purpose: Pipe jo	int length: Height:	Material:	LateralsCounter:	Additional info:	
Maintenan ce Related	15 in.	Vitrified Clay Pipe		manhole correction	on

Structura	ıl:		O&M:					Overall:			
Grade	Defects	Segment Grade	Pipe Rating	Quick Rating	Pipe Rating Index	Defects	Segment Grade	Pipe Rating	Quick Rating	Pipe Rating Index	Pipe Rating	Pipe Rating Index	LoF	Risk
1	0	0				0	1							
2	0	0				0	0							
3	0	0	0	0000	0.0	0	0	65	4B11	3.8	65	3.8	5.0	
4	0	0				0	64							
5	0	0				0	0

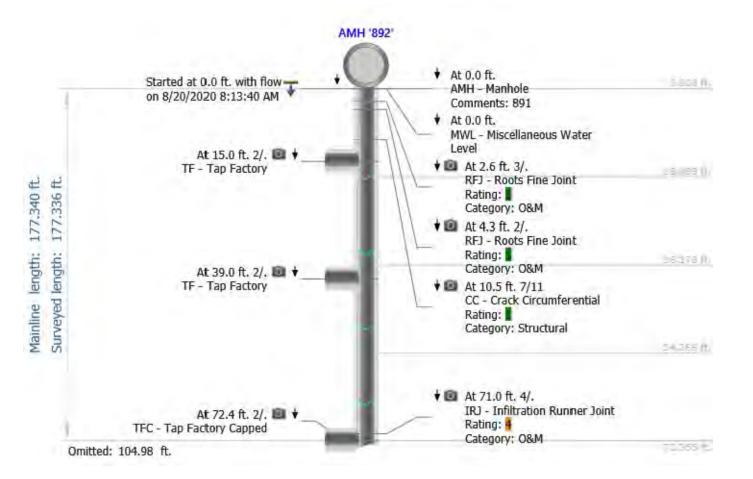
Start date/tim	e: Weather:		Surveyed by:	Certificate number:	Pipe segment ref.:	
20200820 0	8:13 Dry - No	tion during	K.Lang	UO-200-70308438	892-891	
	survey	lion during				
Owner:	Customer	:	Pre-cleaning:	Date cleaned:	Project name:	
			Light Cleaning		TIG001-23	
City:	Street:		Location code:	Pipe use:	Drainage area:	Flow control:
Vernon	Main ST			Sanitary Sewage Pipe		
Upstream MH	No:	Downstrea	m MH No:	Direction:	Total length:	Length surveyed:
892		891		D	177.340 ft.	177.336 ft.
Purpose:	Pipe joint length:	Height:	Material:	LateralsCounter:	Additional info:	
Maintenan ce Related		15 in.	Vitrified Clay Pipe		manhole correcti	on 892-891

Structural:					O&M:					Overall:			
Grade	Defects	Segment Grade	Pipe Rating	Quick Rating	Pipe Rating Index	Defects	Segment Grade	Pipe Rating	Quick Rating	Pipe Rating Index	Pipe Rating	Pipe Rating Index	LoF	Risk
1	0	3				0	2							
2	0	14				0	0							
3	0	3	20	3127	1.8	0	0	6	4112	2.0	26	1.9	4.1	
4	0	0				0	4							
5	0	0				0	0

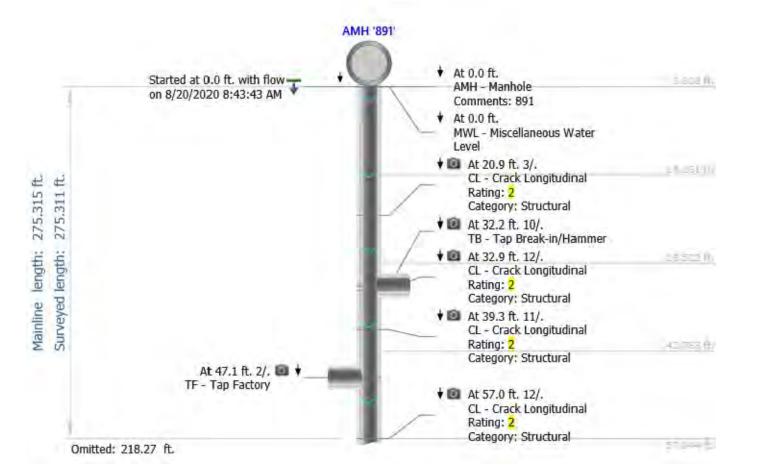
Start date/time:	Weather:		Surveyed by:	Certificate number:	Pipe segment ref.:				
20200820 08:43	Dry - No precipitation	n during	K.Lang	UO-200-70308438	891-2655				
	survey	ii duriiig							
Owner:	Customer:		Pre-cleaning:	Date cleaned:	Project name:				
			Light Cleaning		TIG001-23				
City:	Street:		Location code:	Pipe use:	Drainage area:	Flow control:			
Vernon	Main ST			Sanitary Sewage Pipe					
Upstream MH No:	1	Downstrear	n MH No:	Direction:	Total length:	Length surveyed:			
891		2655		D	275.315 ft.	275.311 ft.			
Purpose: Pipe jo	int length:	Height:	Material:	LateralsCounter:	Additional info:				
Maintenan ce Related ———		15 in.	Vitrified Clay Pipe

Structural:							O&M:			Overall:				
Grade	Defects	Segment Grade	Pipe Rating	Quick Rating	Pipe Rating Index	Defects	Segment Grade	Pipe Rating	Quick Rating	Pipe Rating Index	Pipe Rating	Pipe Rating Index	LoF	Risk	
1	0	3				0	25								
2	0	34				0	4								
3	0	3	40	312B	1.9	0	0	29	221D	1.1	69	1.4	3.1		
4	0	0				0	0								
5	0	0				0	0

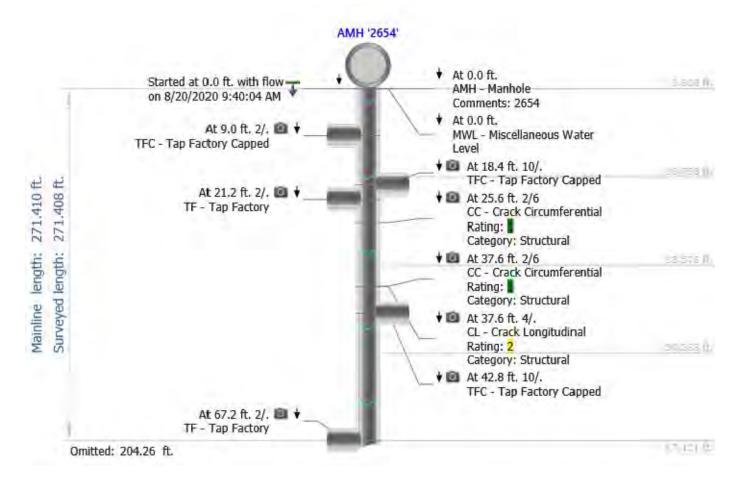
Start date/time:	Weather:		Surveyed by:	Certificate number:	Pipe segment ref.:	
20200820 09:4		ion during	K.Lang	UO-200-70308438	2654-2653	
	survey	ion during				
Owner:	Customer:		Pre-cleaning:	Date cleaned:	Project name:	
			Light Cleaning		TIG001-23	
City:	Street:		Location code:	Pipe use:	Drainage area:	Flow control:
Vernon	Main ST			Sanitary Sewage Pipe		
Upstream MH No	0:	Downstrea	m MH No:	Direction:	· Total length:	Length surveyed:
2654		2653		D	271.410 ft.	271.408 ft.
Purpose: Pi	pe joint length:	Height:	Material:	LateralsCounter:	Additional info:	
Maintenan ce Related —		15 in.	Vitrified Clay Pipe

Structural:							O&M:			Overall:			
Grade	Defects	Segment Grade	Pipe Rating	Quick Rating	Pipe Rating Index	Defects	Segment Grade	Pipe Rating	Quick Rating	Pipe Rating Index	Pipe Rating	Pipe Rating Index	LoF	Risk
1	0	8				0	0							
2	0	4				0	0							
3	0	12	24	3422	1.7	0	0	0	0000	0.0	24	1.7	3.4	
4	0	0				0	0							
5	0	0				0	0

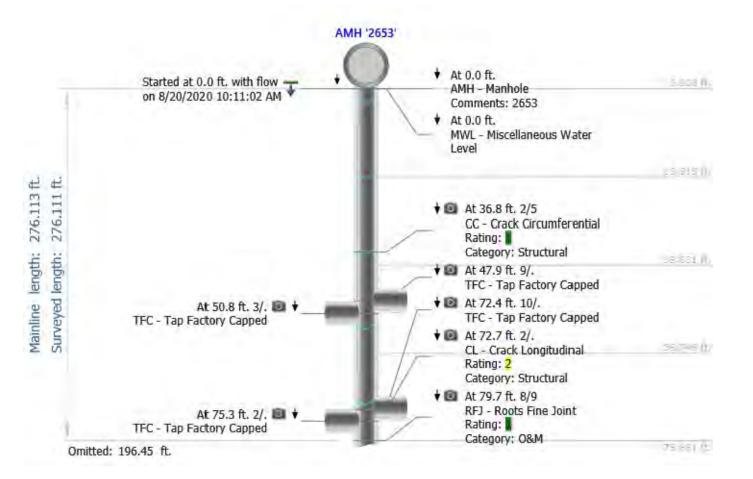
Start date/time:	Weather:		Surveyed by:	Certificate number:	Pipe segment ref.:				
20200820 10:11	Dry - No precipitation	n during	K.Lang	UO-200-70308438	2653-1756				
	survey								
Owner:	Customer:		Pre-cleaning:	Date cleaned:	Project name:				
			Light Cleaning		TIG001-23				
City:	Street:		Location code:	Pipe use:	Drainage area:	Flow control:			
Vernon	Main ST			Sanitary Sewage Pipe					
Upstream MH No:	[	Downstream MH No:		Direction:	Total length:	Length surveyed:			
2653		1756		D	276.113 ft.	276.111 ft.			
Purpose: Pipe joi	int length:	Height:	Material:	LateralsCounter:	Additional info:				
Maintenan ce Related		15 in.	Vitrified Clay Pipe

Structural:							O&M:			Overall:				
Grade	Defects	Segment Grade	Pipe Rating	Quick Rating	Pipe Rating Index	Defects	Segment Grade	Pipe Rating	Quick Rating	Pipe Rating Index	Pipe Rating	Pipe Rating Index	LoF	Risk	
1	0	6				0	3								
2	0	4				0	0								
3	0	3	13	3122	1.4	0	0	3	1300	1.0	16	1.3	3.1		
4	0	0				0	0								
5	0	0				0	0

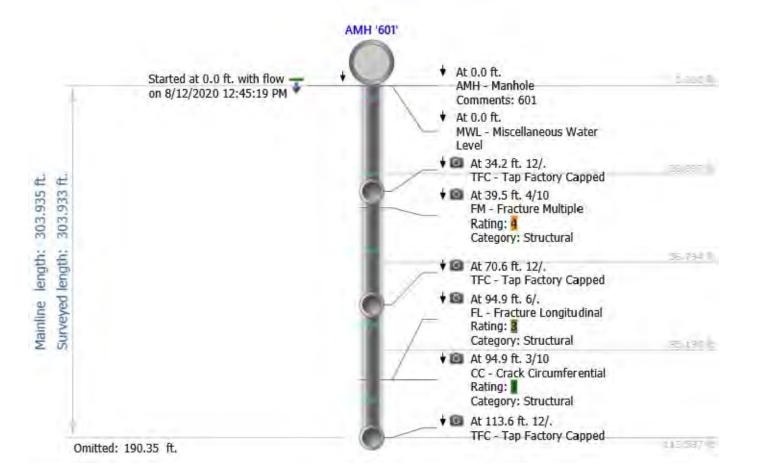
Start date/time:	Weather:		Surveyed by:	Certificate number:	Pipe segment ref.:	
20200812 12:45	Dry - No	ion during	alberto	u-0220-70308624	601-1955	
	survey	ion during				
Owner:	Customer:		Pre-cleaning:	Date cleaned:	Project name:	
			Light Cleaning		TIG001-23	
City:	Street:	reet: Location code:		Pipe use:	Drainage area:	Flow control:
VERNON CT	ELM ST			Sanitary Sewage Pipe		
Upstream MH No:		Downstrea	am MH No:	Direction:	Total length:	Length surveyed:
601		1955		D	303.935 ft.	303.933 ft.
Purpose: Pipe	joint length:	Height:	Material:	LateralsCounter:	Additional info:	
Maintenan ce Related		8 in.	Vitrified Clay Pipe		CANT SEE MH DU	E TO L SHAPED INVERT

Structural:							O&M:			Overall:			
Grade	Defects	Segment Grade	Pipe Rating	Quick Rating	Pipe Rating Index	Defects	Segment Grade	Pipe Rating	Quick Rating	Pipe Rating Index	Pipe Rating	Pipe Rating Index	LoF	Risk
1	0	3				0	3							
2	0	2				0	0							
3	0	6	31	4532	2.8	0	0	3	1300	1.0	34	2.4	4.5	
4	0	20				0	0							
5	0	0				0	0

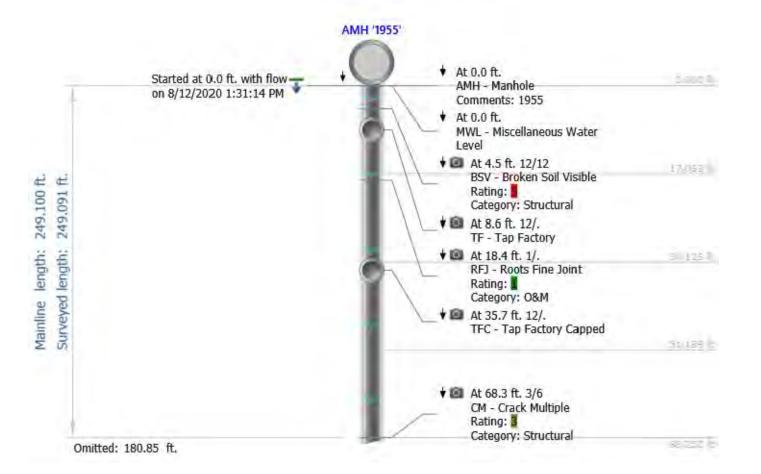
Start date/time:	Weather:		Surveyed by:	Certificate number:	Pipe segment ref.:	
20200812 13:		ion during	alberto	u-0220-70308624	1955-1954	
	survey	ion during				
Owner:	Customer:		Pre-cleaning:	Date cleaned:	Project name:	
			Light Cleaning		TIG001-23	
City:	Street:		Location code:	Pipe use:	Drainage area:	Flow control:
VERNON CT	ELM ST			Sanitary Sewage Pipe		
Upstream MH N	0:	Downstrea	m MH No:	Direction:	Total length:	Length surveyed:
1955		1954		D	249.100 ft.	249.091 ft.
Purpose: Pi	pe joint length:	Height:	Material:	LateralsCounter:	Additional info:	
Maintenan ce Related —		8 in.	Vitrified Clay Pipe

Structura	ıl:				O&M:				Over	rall:	
Grade	Defects	Segment Grade	Pipe Rating	Quick Rating	Pipe Rating Index	Defects	Segment Grade	Pipe Rating	Quick Rating	Pipe Rating Index	Pipe Rating	Pipe Rating Index	LoF	Risk
1	0	0				0	1							
2	0	0				0	0							
3	0	6	23	5143	3.8	0	0	1	1100	1.0	24	3.4	5.1	
4	0	12				0	0							
5	0	5				0	0

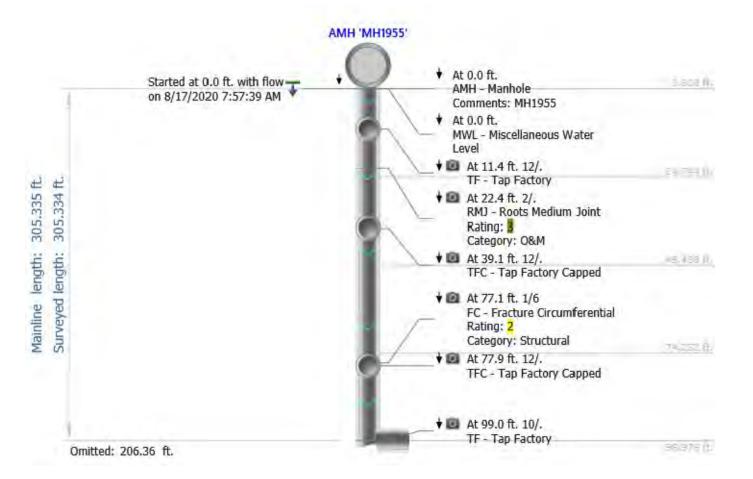
Surveyed by: Weather: Start date/time: Certificate number: Pipe segment ref.: 20200817 07:57 Dry - No UO-200-70308438 MH1955-MH1954 K.Lang precipitation during survey Owner: Customer: Pre-cleaning: Date cleaned: Project name: **Light Cleaning** TIG001-23 Flow control: City: Street: Location code: Pipe use: Drainage area: **ELM STREET Sanitary Sewage VERNON CT** Pipe Upstream MH No: Downstream MH No: Direction: Total length: Length surveyed: MH1955 MH1954 305.335 ft. D 305.334 ft. Purpose: Pipe joint length: Height: Material: LateralsCounter: Additional info: Maintenan 8 in. Vitrified Clay ce Related Pipe

Structura	ıl:				O&M:				Over	all:	
Grade	Defects	Segment Grade	Pipe Rating	Quick Rating	Pipe Rating Index	Defects	Segment Grade	Pipe Rating	Quick Rating	Pipe Rating Index	Pipe Rating	Pipe Rating Index	LoF	Risk
1	0	3				0	0							
2	0	2				0	2							
3	0	0	13	4221	2.2	0	6	8	3221	2.7	21	2.3	4.2	
4	0	8				0	0							
5	0	0				0	0
